INSPECTION REPORT: KENSINGTON GOLD MINE

Date of Inspection: Wednesday January 31, 2018
Date of Report: Thursday February 8, 2018
USDA Forest Service Inspector: Richard Dudek

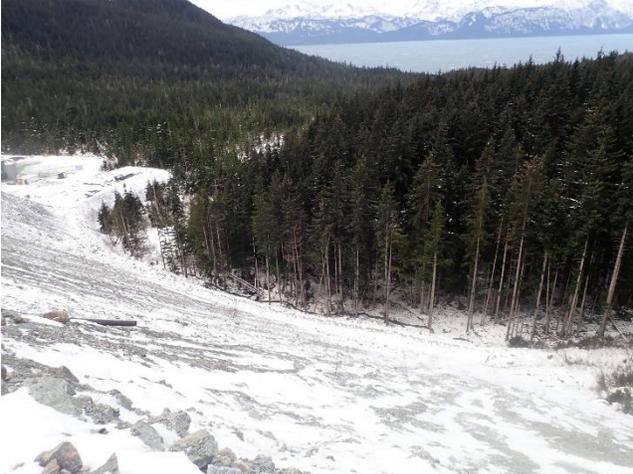
This site is currently inactive (Photo 1).

Photo 1. The Comet development pile.

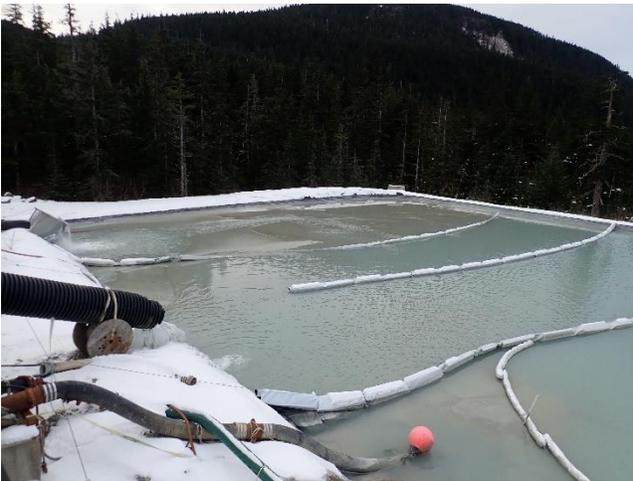
On 1/31/2018, the CWTP was treating 1,400 gallons of water per minute (gpm). Pond-1 (Photo 2) was receiving mine site water, and Pond-2 (Photo 3) was receiving backwash from the CWTP. Since Coeur Alaska installed multiple silt curtains in Pond -1, the majority of sediments have accumulated to a small section in the pond. This spring, Coeur Alaska will dredge both ponds to remove sediment buildup. The dredging process will take two to three weeks for each pond. Good housekeeping practices (2016 BMP plan Table 4-1) were observed inside the CWTP.

Photo 2. The Comet water treatment plant, pond-1.

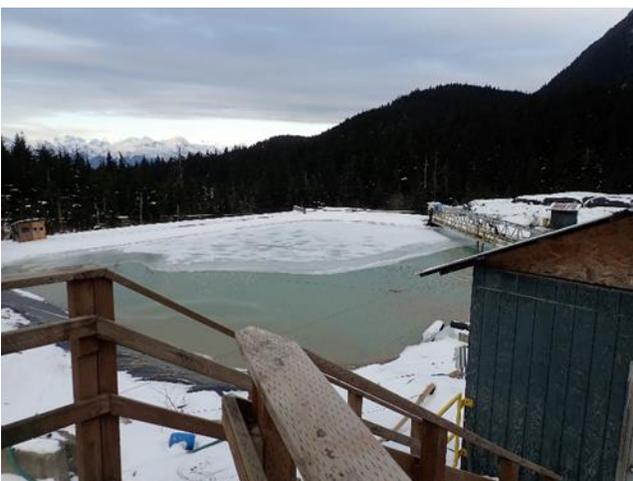
Photo 3. The Comet water treatment plant, pond-2.

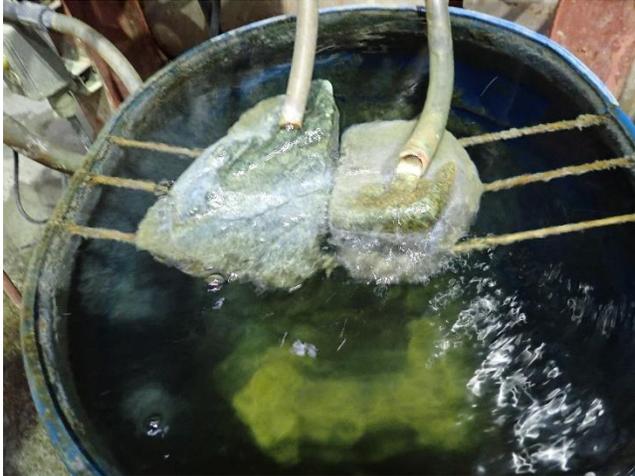
White material was observed on the test rock used for monitoring white material in treated mine site water (Photo 4). Personnel at the water treatment plant first observed and recorded traces of white material on 1/22/2018. Coeur Alaska is bench testing different flocculants and coagulants to help precipitate white material out of solution. The water treatment plant personnel are currently conducting a one-month trial test using calcium chloride (CaCl_2) (Photo 5) to precipitate white material out of solution.

Photo 4. White filmy material coating the test rocks.

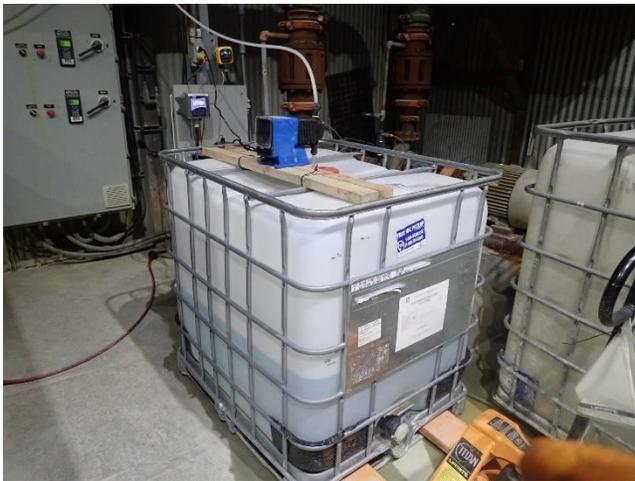
Photo 5. A 300-gallon tote of Calcium Chloride (CaCl).

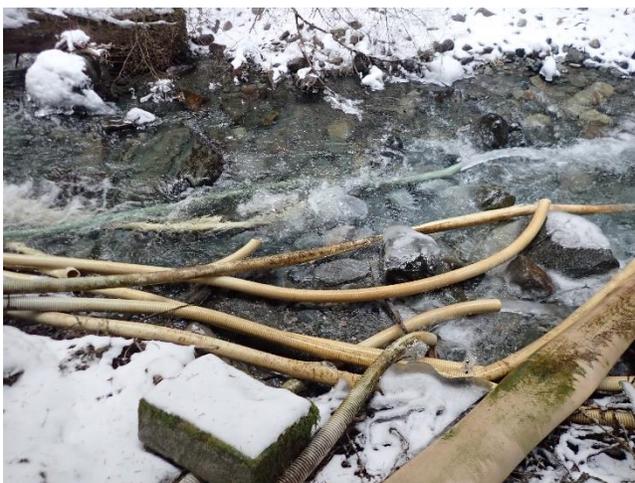
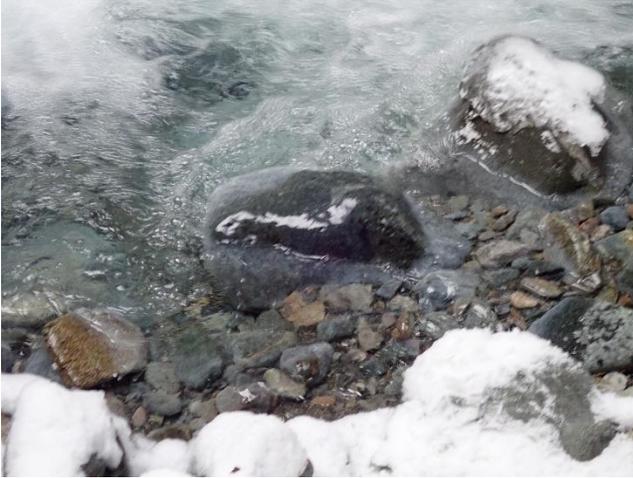
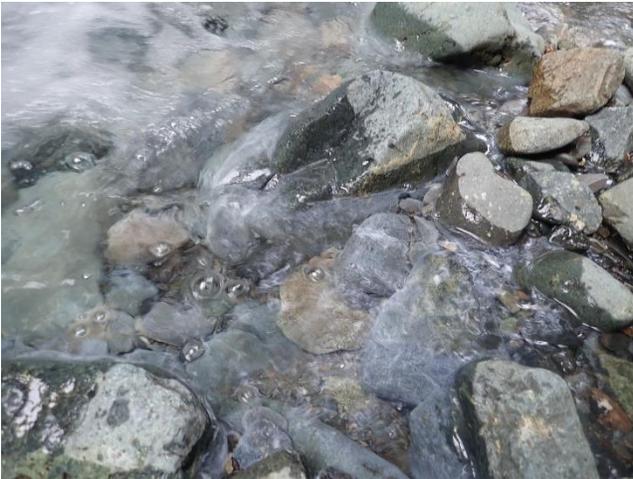
White material was observed in Sherman Creek. Several rocks in the creek bed appear to have a white filmy coating (Photos 6-8).

Photo 6. Sherman Creek (outfall 001).

Photo 7. Sherman Creek.

Photo 8. Sherman Creek.

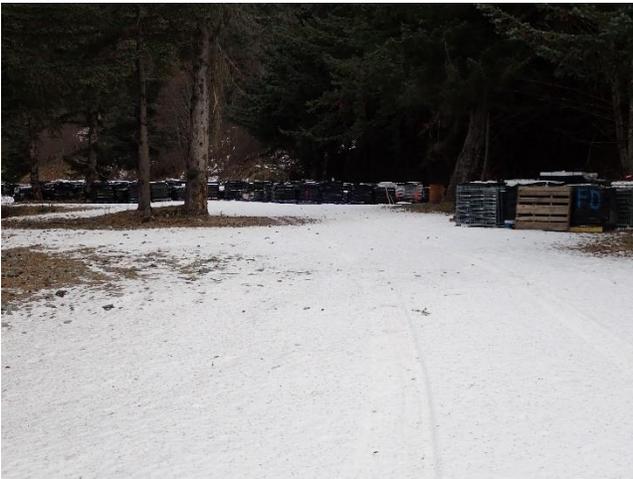
The rock core from the 2017 geotechnical drilling is currently staged at this location is on a patented claim (Photo 9).

Photo 9. Comet beach area.

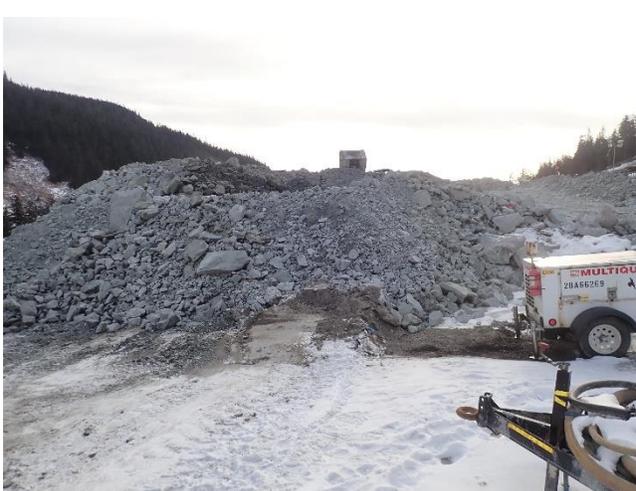
All waste rock generated from the underground workings is currently being deposited at the Kensington development pile (Photo 10).

Photo 10. The Kensington development pile.

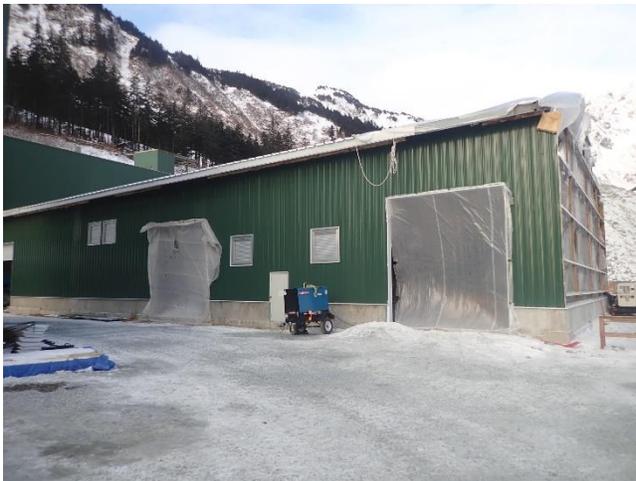
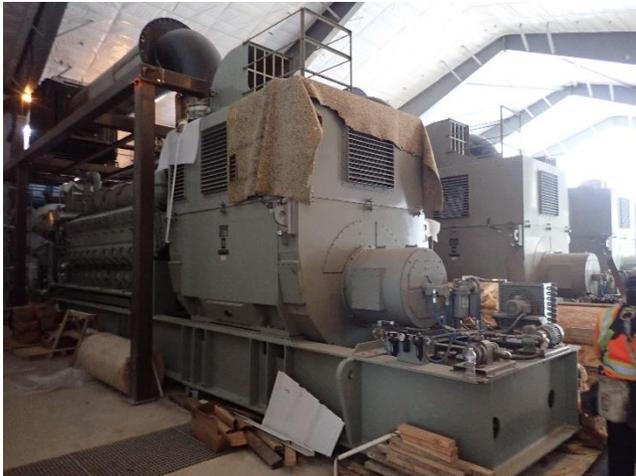
Contractors continue with the construction of the new powerhouse station (Photos 11-12). Coeur Alaska plans to bring the four new 4-megawatt generators online this spring to provide power to the mine site.

Photo 11. The powerhouse station.

Photo 12. Staged inside the new powerhouse are the 4 four-megawatt generators.

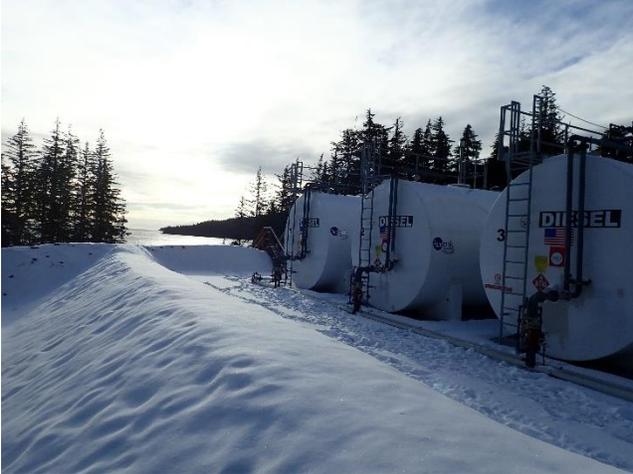
- **Snow and ice buildup in the fuel tank farm.**

The fuel tank's structural gravel pad was covered in snow and ice (Photo 13). The 2014 fuel depot handbook pages 4-6 state that daily/monthly inspections take place, which include the fuel tank's secondary containment. The fuel tank farm's structural gravel pad is considered secondary containment. With snow and ice covering the pad, the total volume capacity for secondary containment has been reduced. In the event of a major fuel spill, the tank farms secondary containment may not be adequate to hold 110% of the volume. Snow and ice accumulation should be monitored, and removed if it is impacting the capacity to store 110% of the volume of a single tank.

Photo 13. The Coeur Alaska fuel depot.

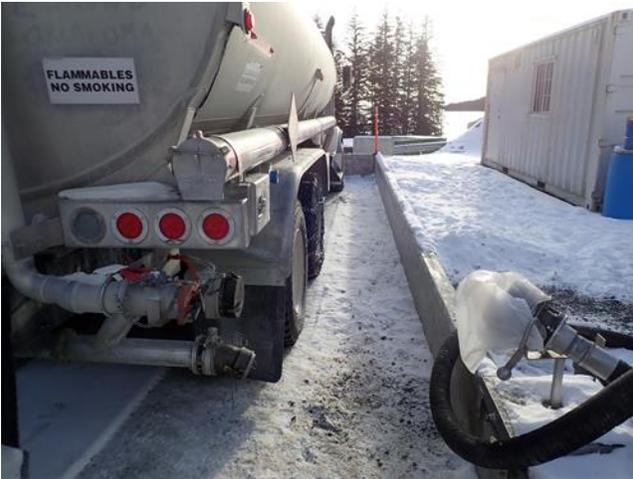
The refueling pad did not show any indications of fuel spills during refueling of the fuel truck (Photo 14).

Photo 14. The fuel depot's refueling pad.

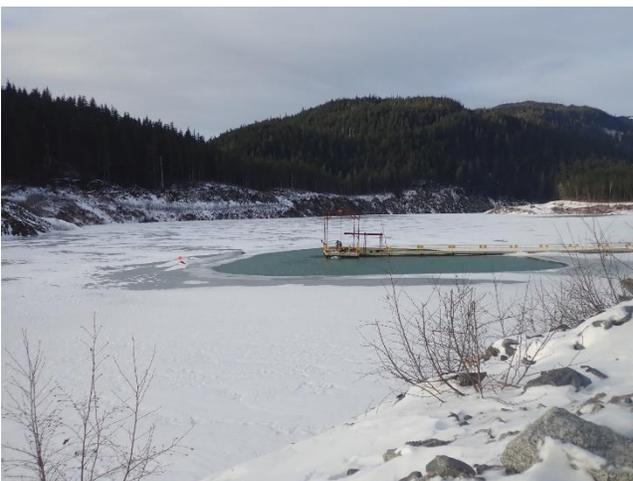
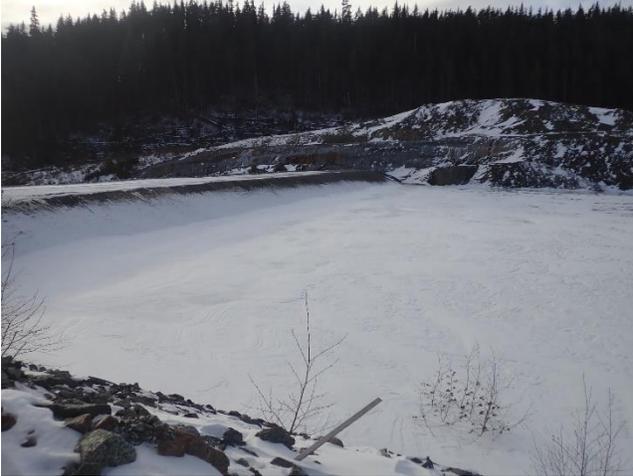
The TTF was mostly frozen over and the recorded water level on 1/31/2018 was 703.65 feet (Photo 15-16). The stage 2 dam design is permitted for a maximum water elevation of 697.3 feet, which is based on the 200-year storm surge. The current water elevation does not comply with the maximum water

elevation stated in Coeur Alaska's Plan of Operations (POO). Coeur Alaska personnel are aware of this and are working on keeping the water levels from steadily increasing prior to the stage 3 dam elevation raise.

On 1/31/2018, the water treatment plant was discharging 1,410 gpm. To help treat total dissolved solids (TDS) and sulfate (SO_4). The TTF water treatment plant personnel have been diluting the water with fresh water from the Upper Slate Lake diversion in order to meet the APDES permit limits. Which this process is causing a reduction in the net treatment rates, and causing water levels in the TTF to rise.

Photo 15. The tailings treatment facility (TTF).

Photo 16. Southern TTF and the TTF dam.

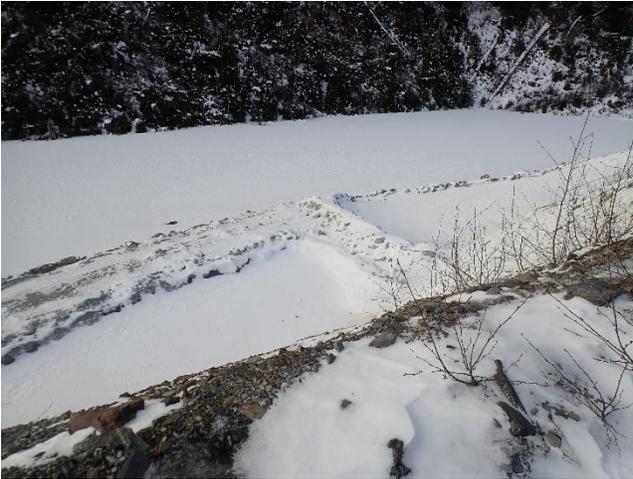
In the northern TTF, the acid rock drainage (ARD) collection ditch was frozen over and covered in snow (Photo 17). Waste rock was added to the collection ditch berms height in December of 2017 to prevent inundation from rising water levels in the TTF.

Photo 17. The northern TTF area.
